Manhole Inspection Summary

Manhole # S35AA_036MH

Insp Date: **11/15/07 8:59 AM**

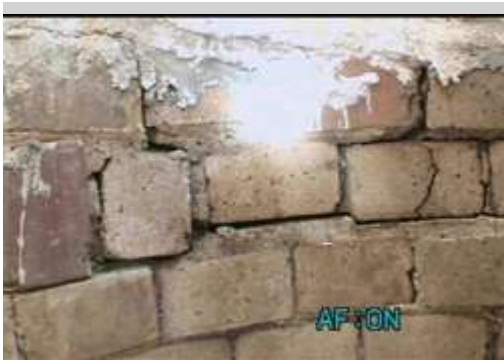
Defect 3

Condition: ☐ Sound ☒ **Cracked** ☐ Root Intrusion ☒ **Loose Brick** ☐ Deteriorated

CORBEL_COND_CRACK ,
CORBEL_COND_LOOSE_BRICKS

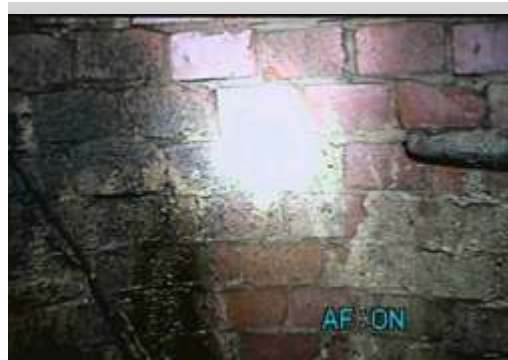
Defect 2

Infiltration: ☐ None ☐ Joint ☐ Cracks ☒ **Mortar** ☐ Roots ☐ Wall

infiltration in barrel mortar

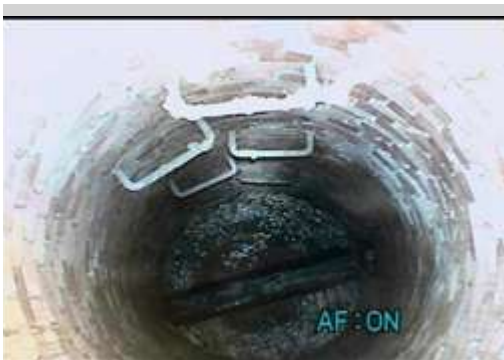
Defect 1

Steps Count: **6** Missing: **0** ☒ **Corroded**

steps

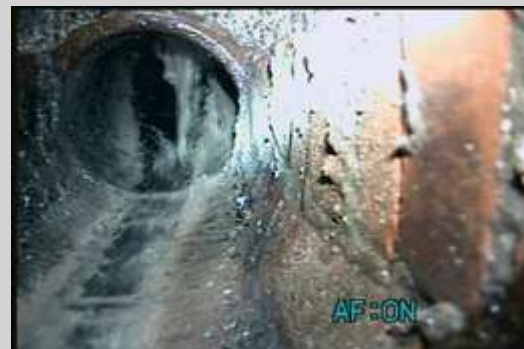
Drop In @ 6 O'Clock

Drop: Outside Direct

Drop Condition: Open

Connects To: Dead End
